WL-TM-91-307-FIBG

ADD-ON DAMPING TREATMENT FOR LIFE
EXTENSION OF THE F-15 UPPER-OUTER
WING SKIN

ACOUSTICS AND SONIC FATIGUE GROUP
STRUCTURAL DYNAMICS BRANCH

30 SEPTEMBER 1991

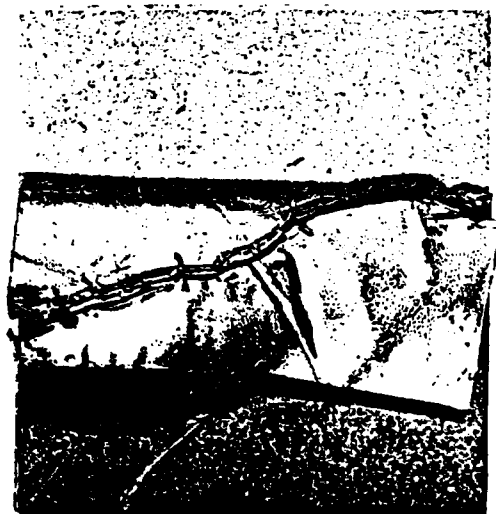
This appendix presents the result of the thermal aging tests performed on the candidate damping treatments. Figure D1 is a photo of a "1980 Damping Treatment" (lay-up 112) which was removed from an actual wing previously in service. The damping treatment was peeled back (failing cohesively) to reveal the original painted surface of the UOWS. The environment was normal service only. There was no evidence of discoloration or embrittlement whatsoever. A specimen containing the "1980 Damping Treatment" and exposed to 340° F in air for 8 hours is shown in Figure D2. When the aluminum constraining layer was peeled back, VEM remained on both the aluminum constraining layer and on the base panel. This is indicative of a cohesive failure which is the desired failure mode. Cohesive failure indicates that thermal aging has not caused debonding of the damping treatment from the parent material. In Figure D2, there are regions where discoloration of the VEM is evident, along with regions (approximately 50% of the area) which experienced no noticeable discoloration. This pattern suggested that air had reached the discolored areas and had not reached the unaffected areas. Possibly the air was entrapped when the foil was laid down, or perhaps a slight ridge or buckle of foil was present.

Figure D1. "1980 Damping Treatment" Exposed to
Actual Field Service
